Flood Control Project Maintenance
2019 Structure Summary Report
Overall Unit and Item Ratings

Clover Creek Diversion Structure

Flood Control Project Maintenance
Unit Cover Sheet
2019 Structure Inspection Results

Levee Inspection Report By Mile - Structure 2019

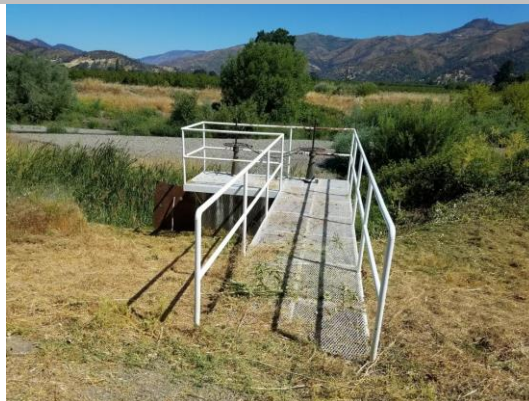
Photo 1 of 1 : ST_2019_NA0009_36_1_20190703_00017.jpg

LM Start	0.00	Rating **	N	Issue No.	1
LM End	0.00	Issue Type +	Ma	Location *	
Category	Structures & Concrete Lined Channels	GPS Latitude/Longitude			
		Start	End		
Item	Photo Documentation	39.177050 °		39.177050 °	
		-122.898750 °		-122.898750 °	
DWR ID	DWR_NA0009_36_t_2012_1				
Action/Comments					
Inspector Comments: Clover Creek Diversion Structure consists of a weir structure, a concrete headwall with six 36-inch CMP culverts and a steel walkway. Two of the six pipes have screw gates, the rest appear to have hand operated slide gates. This structure is designed to limit flows to Clover Creek to a maximum of 500fcs while diverting the remaining flood flows west to Middle Creek.

View of the structure. Summer 2019.

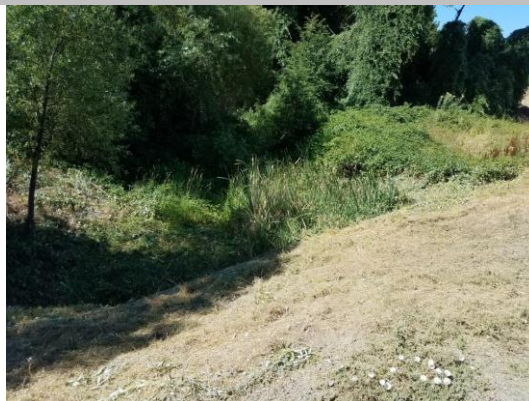
Photo 1 of 3 : ST_2019_NA0009_36_2_20190703_00018.jpg

LM Start	0.00	Rating **	M	Issue No.	2
LM End	0.00	Issue Type +	Ma	Location *	
Category	Structures & Concrete Lined Channels	GPS Latitude/Longitude			
		Start	End		
Item	Vegetation & Obstructions	39.177050 °		39.177050 °	
		-122.898750 °		-122.898750 °	
DWR ID	DWR_NA0009_36_t_2012_2				
Action/Comments					
Inspector Comments: The channel had vegetation that appear to block 25% of the capacity.

View of the vegetation at the outlet of the structure. Summer 2019.

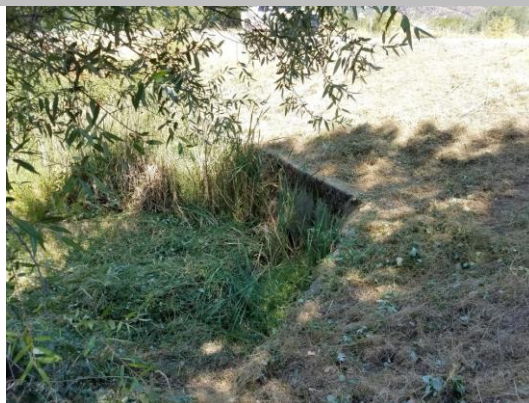
Photo 2 of 3 : ST_2019_NA0009_36_2_20190703_00019.jpg

View of the vegetation looking at the outlet culverts. Summer 2019.

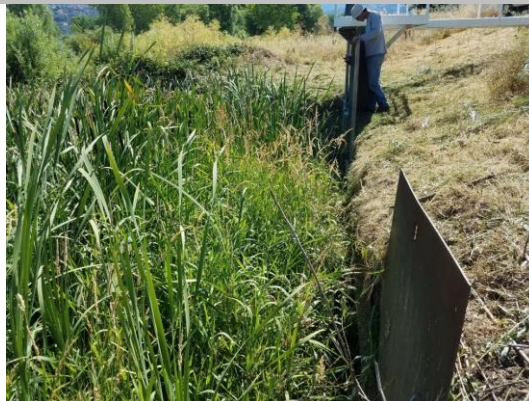
Photo 3 of 3 : ST_2019_NA0009_36_2_20190703_00020.jpg

LM Start	0.00	Rating **	M	Issue No.	2 (cont)	
LM End	0.00	Issue Type +	Ma	Location *		
Category	Structures & Concrete Lined Channels			GPS Latitude/Longitude		
				Start		End
Item	Vegetation & Obstructions			39.177050 °		39.177050 °
				-122.898750 °		-122.898750 °
DWR ID	DWR_NA0009_36_t_2012_2					
Action/Comments						
Inspector Comments: The channel had vegetation that appear to block 25% of the capacity.

View of the vegetation at the concrete headwall slide gates and culverts.
Spring 2019.

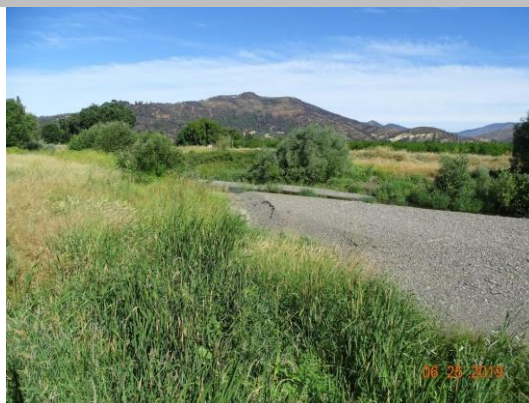
Photo 1 of 5 : ST_2019_NA0009_36_3_20190701_00012.jpg

LM Start	0.00	Rating **	U	Issue No.	3
LM End	0.00	Issue Type +	Ma	Location *	
Category	Structures & Concrete Lined Channels			GPS Latitude/Longitude	
				Start	End
Item	Shoaling / Sedimentation			39.177050 °	39.177050 °
				-122.898750 °	-122.898750 °
DWR ID	DWR_NA0009_36_t_2012_3				
Action/Comments					
Inspector Comments: Significant gravelbar is impeding the flow of the channel. A new channel upstream created from the gravel reroutes low flows past the structure. The bar appears to be higher than the slide gates on the concrete headwall. However, a backchannel has formed that allows some water to flow through the slide gates and culverts. Lake County is working to secure environmental permits to excavate the gravel.

View of the gravelbar, facing downstream from the control structure.
Summer 2019.

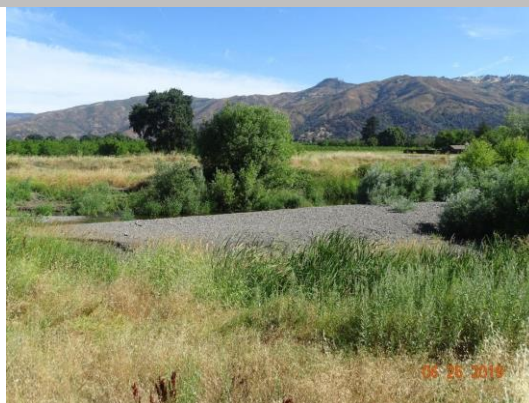
Photo 2 of 5 : ST_2019_NA0009_36_3_20190701_00016.jpg

View of the gravelbar, facing upstream from the control structure.
Summer 2019.

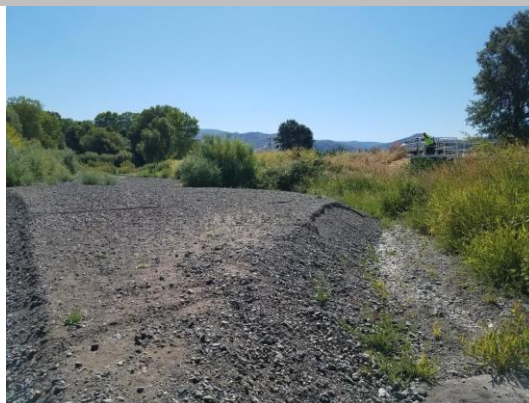
Photo 3 of 5 : ST_2019_NA0009_36_3_20190703_00021.jpg

LM Start	0.00	Rating **	U	Issue No.	3 (cont)	
LM End	0.00	Issue Type +	Ma	Location *		
Category	Structures & Concrete Lined Channels			GPS Latitude/Longitude		
				Start	End	
Item	Shoaling / Sedimentation			39.177050 °	39.177050 °	
				-122.898750 °	-122.898750 °	
DWR ID	DWR_NA0009_36_t_2012_3					
Action/Comments						
Inspector Comments: Significant gravelbar is impeding the flow of the channel. A new channel upstream created from the gravel reroutes low flows past the structure. The bar appears to be higher than the slide gates on the concrete headwall. However, a backchannel has formed that allows some water to flow through the slide gates and culverts. Lake County is working to secure environmental permits to excavate

View of back-channel that has formed, facing towards the control structure. Summer 2019.

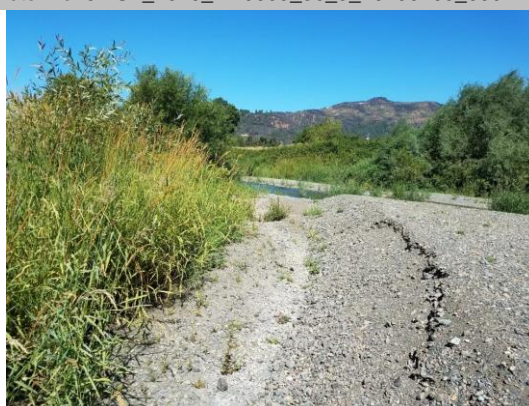
Photo 4 of 5 : ST_2019_NA0009_36_3_20190703_00024.jpg

View of the back-channel from the control structure. Summer 2019.

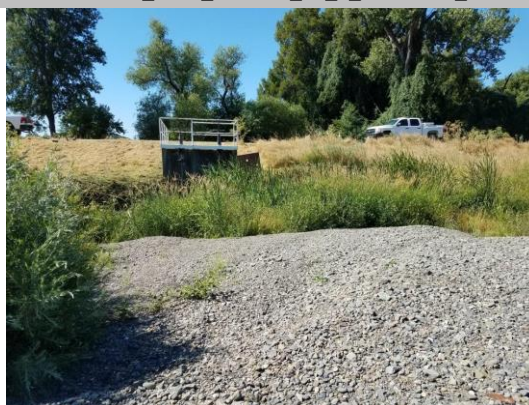
Photo 5 of 5 : ST_2019_NA0009_36_3_20190703_00023.jpg

View of the control structure from the gravelbar. Summer 2019.

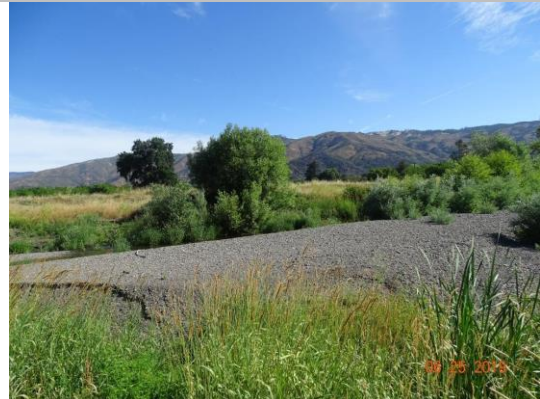
Photo 1 of 1 : ST_2019_NA0009_36_7_20190701_00015.jpg

LM Start	0.00	Rating **	M	Issue No.	7
LM End	0.00	Issue Type +	Ma	Location *	
Category	Structures & Concrete Lined Channels			GPS Latitude/Longitude	
				Start	End
Item	Culverts: Inlets / Outlets			39.177050 °	39.177050 °
				-122.898750 °	-122.898750 °
DWR ID	DWR_NA0009_36_t_2012_7				
Action/Comments					
Inspector Comments: Minor vegetation at the outlet and inlet. It doesn't appear to block over 10% of the opening.

View of gravel blocking the culvert inlets. Summer 2019.

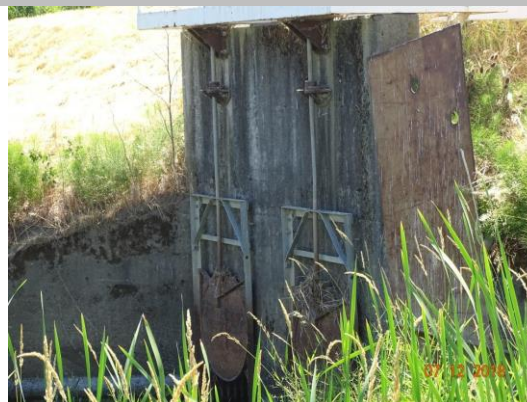
Photo 1 of 1 : ST_2019_NA0009_36_12_20190625_00006.jpg

LM Start	0.00	Rating **	A	Issue No.	12
LM End	0.00	Issue Type +	Ma	Location *	
Category	Structures & Concrete Lined Channels			GPS Latitude/Longitude	
				Start	End
Item	Sluice/Slide Gates			39.177050 °	39.177050 °
				-122.898750 °	-122.898750 °
DWR ID	DWR_NA0009_36_t_2012_12				
Action/Comments					
Inspector Comments: The slide gates appeared to be in good working condition.

View of the slide gates. Summer 2018.

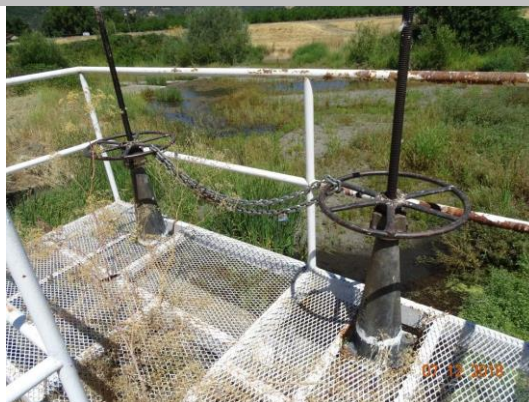
Photo 1 of 1 : ST_2019_NA0009_36_14_20190625_00007.jpg

LM Start	0.00	Rating **	A	Issue No.	14
LM End	0.00	Issue Type +	Ma	Location *	
Category	Structures & Concrete Lined Channels			GPS Latitude/Longitude	
				Start	End
Item	Manual Gate Operators			39.177050 °	39.177050 °
				-122.898750 °	-122.898750 °
DWR ID	DWR_NA0009_36_t_2012_14				
Action/Comments					
Inspector Comments: The manual gate operators appeared to be operational.

View of the manual gate operators. Summer 2018.
